BELZONA EXPANSION JOINT REPAIR HELPS A COAL MINE STAY ENVIRONMENTALLY COMPLIANT

Coal terminal, Alabama, USA

Expansion joints of a concrete dock.

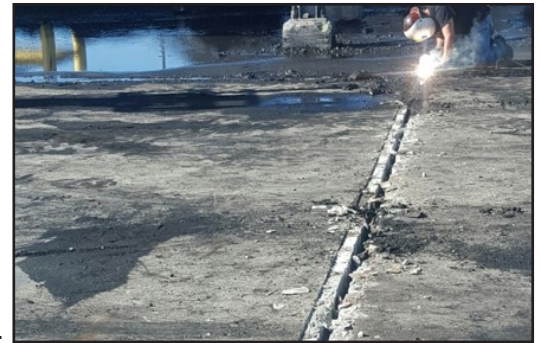
1. Removal of nosing and damaged concrete.
2. Concrete restoration of Belzona 4131.
3. Backer rod inserted prior to an application of Belzona 2211.
4. Expansion joint repair complete.

The repair area was pressure washed to remove all coal dust in and around the joint. Then, the metal nosing, all old rubber and other previously used joint materials were removed and the concrete areas were re-cleaned. Concrete areas were leveled by means of manual grinding. Belzona 4131 was used to build up the damaged concrete. Once Belzona 4131 was applied, this area was not accessible for any traffic until the following day, when Belzona 2211 was mixed and applied with the use of form boards and a backer rod.
