## BELZONA 3111 TO WATERPROOF A STUNNING NEW BUILD DEVELOPMENT

**CUSTOMER**  
Paris, France

**APPLICATION SITUATION**  
Three new builds required a water and weatherproofing system for a surface area of 2700m<sup>2</sup> (29,000ft<sup>2</sup>)

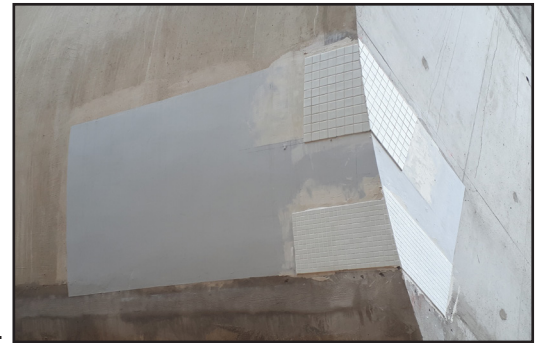
- PICTURES**
1. A close up of the Belzona 3111 with the tiles bonded on top
  2. 2 to 4 - Application in progress

**APPLICATION METHOD**  
Belzona 3111 was rolled onto the roof to completely encapsulate it. Then it was overcoated with an adhesive to bond the tiles.
