BELZONA 1212 SEALS PROPULSION SHAFT FLANGE

CUSTOMER
Alaska, USA

APPLICATION DATE
January 2016

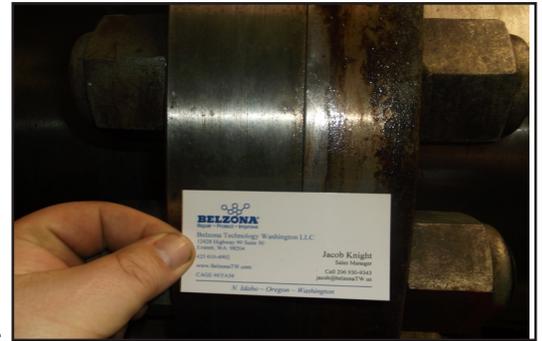
APPLICATION SITUATION
Oil leaking from the flange when the propulsion shaft is spinning.

PROBLEM
This flange is not designed to retain oil, but since there is a hose inside the propulsion shaft leaking oil, the need to seal off the flange to keep oil from being sprayed all over the engine compartment is very important for many reasons including personal safety. The second part of this problem is that the supply tank is over 40' above the shaft and cannot be shut off. This means the oil leak had to be stopped while under pressure.

1. Showing the size of this oily flange.
2. First layer of Belzona 1212 with Belzona 9341.
3. Second coat of Belzona 1212.
4. Final application of Belzona 1212, all oil leaks stopped.

APPLICATION METHOD
The repair was carried out following a modified version of Belzona Know-How System Leaflet VPF-11. A hand grinder was used to clean and prep the steel. Belzona 1212 was mixed and most of its working life allowed to pass prior to application in order to stop the oil leak.
