BELZONA ALTERS YACHT WINDOW FRAMES WITH EASE

CUSTOMER
Mallorca

APPLICATION DATE
June 2018

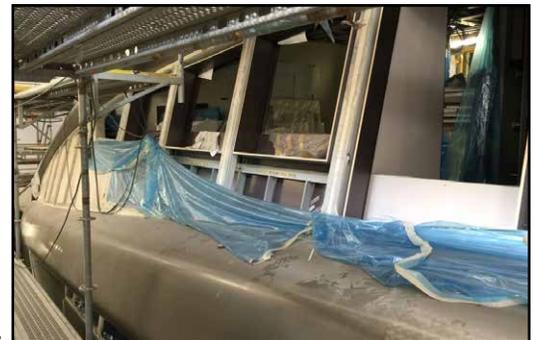
APPLICATION SITUATION
A newly built yacht window installation without 216 linear meters of window frame.

- PICTURES**
1. General view of window frames
 2. Surface being prepared for application
 3. Belzona applied with formers in place
 4. Completed application
