## BELZONA SECURES A LIFTING WINCH

Lifting winch being secured on the deck of a dredging vessel

Chocking of heavy machinery winch.

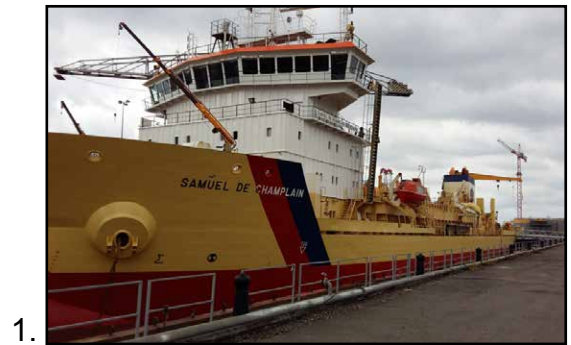
1. Dredging vessel
2. Area marked and dammed, ready for application
3. Pouring in progress
4. Completed application

The 4 supporting pads were chocked using Belzona 7111 in order to ensure optimum load transmission as well as long term protection against vibration. The fast curing properties of the material were a key factor for the operator of the ship.
