ANTI-CORROSION PROTECTION BY BELZONA

Anti-corrosion protection of a sulfuric acid tank together with the existing infrastructure.

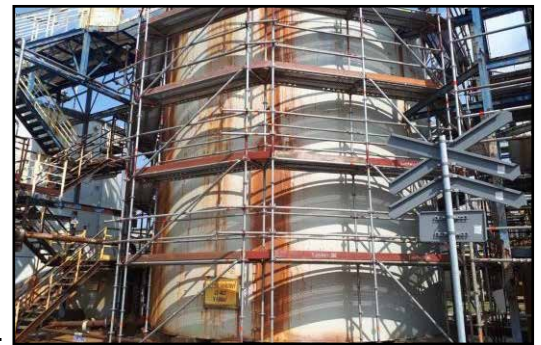
Degradation of the existing anti-corrosion system and rapidly progressing corrosion of steel. Exposure to UV rays and atmospheric precipitation. A very aggressive chemical industry environment and fumes of sulfuric acid. Periodic pouring with sulfuric acid of 97% concentration and 40C temperature.

1. Corrosion of the sulfuric acid tank
2. Application of the chemical resistant composite Belzona 5811
3. Application of the topcoat layer of Belzona 5111
4. Application Complete
