BELZONA KNOWS HOW TO REBUILD A DIAPHRAGM PUMP

Potato processing plant.

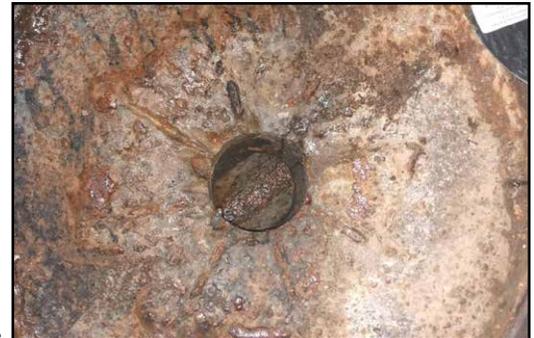
This 30" diaphragm pump was not performing as it should, so Belzona was asked to rebuild it. The pump was originally installed in the 1960's and has been operating pretty much full time since. Once opened, the cause of the lack of performance was revealed as there was quite a bit of erosion and metal loss.

1. The pump opened.
2. The pump cleaned.
3. The pump rebuilt with Belzona 1111.
4. The pump coated with Belzona 5831
