BELZONA PRODUCTS REPAIR AND WATERPROOF WIND TURBINE BASE

Wind Farm Bases needed reconstruction and weatherproofing with a non-porous product that could also protect the base from freeze-thaw cycle.

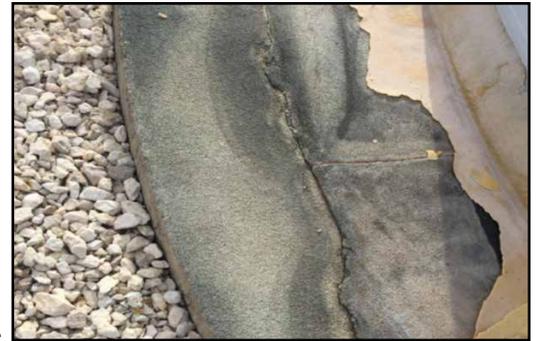
After years of service the interface between the wind turbine tower and the concrete base deteriorated because of water ingress and freeze-thaw. An unknown product was used as a repair but never bonded correctly to the concrete and cracked along with the old concrete. Also the sealant in the expansion joint failed in the area between the tower base and the concrete and the gap had gotten very wide. Water was ingressing into the tower base structure itself. The tower itself was vibrating during operation because of the gaps and crack around it.

1. Damaged concrete base with coating peeling.
2. Damaged concrete base seeing old grout not bonded to the old concrete.
3. Belzona 4131 bonding the old concrete and old grout forming a new circular base. Belzona 4511 expansion joint product applied in the interface. Belzona 3111 being applied around the finished base.
4. The whole base up to the metal structured completely weatherproofed with 3111.

Took all loose concrete and old loose grout out. The perimeter area of the tower was grouted with Belzona 4131. Belzona 4131 was used to make a new circular base around the interface. Belzona 4511 was then used in the interface area as the expansion joint sealant between the concrete and the metal. Finally the whole tower base was waterproofed up to the metal with Belzona 3111.
