## BELZONA RECASTS NEW PERIMETER EXPANSION JOINTS FOR OUTDOOR POOL

The expansion joints of an outdoor pool

All expansion joints were replaced as part of a major refurbishment project.

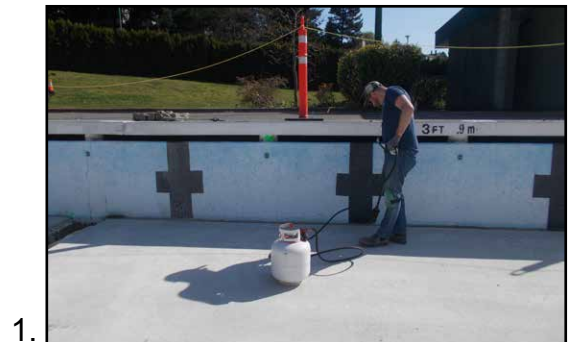
1. Joints needed to be dried out prior to casting
2. Joints masked off for a neat and tidy finish
3. Injection of Belzona 2221 into expansion joint slot
4. Completed joint.
