## BELZONA SOLUTION FOR COOLING TOWER WATER CIRCULATION PUMPS

Petrochemicals Company, Saudi Arabia

Discharge head, discharge elbow, column pipes, upper casing and suction bells of a Cooling Tower Water Circulation Pump.

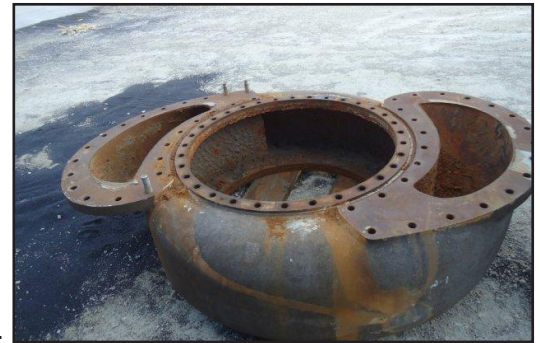
This Cooling Tower Water Circulation Pump was suffering from erosion and corrosion on all internal surfaces and corrosion on external surfaces

1. Damage beforehand
2. Damage beforehand
3. Application in progress
4. Completed application

The applications were undertaken in accordance to modified versions of Belzona Know-How System Leaflets CEP-5, CEP-3, CEP-4. Belzona 1111 was applied directly over the blasted metal surface to rebuild weld joints, pitting, depression and eroded surface. For internal surfaces, apply two-coats with Belzona 1341. For External surfaces, the surface was primed with Belzona 3921 two coats of Belzona 5811 were applied.
