## BELZONA TECHNOSOL APPLY INTERNAL LINING TO HEAT EXCHANGER SHELL

Oil refinery, North West England

February 2019

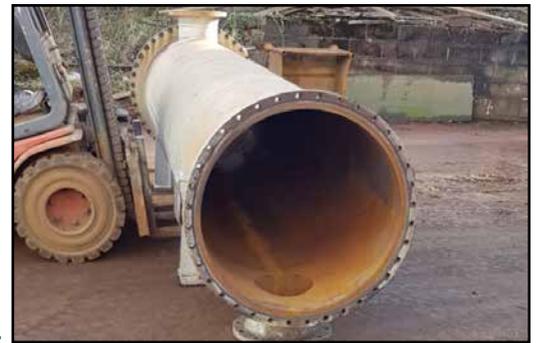
1. Equipment delivered to Belzona Technosol workshop
2. Extent of the damage
3. First coat of Belzona 1593
4. Second coat Belzona 1593

The heat exchanger was dismantled and delivered to the Belzona Technosol workshop in to two parts - the main shell and the dome end. The internal substrate was grit blasted in our workshop under controlled conditions. The pitted steel within the shell was then repaired using Belzona 1511. Following this two Belzona 1511 Nozzle Inserts were bonded into both drain and vent nozzles on the cap end, guaranteeing total encapsulation within these areas. Following the repair, two coats of Belzona 1593 were applied to provide long-term protection. Completed in accordance with Belzona System Leaflet HEX-03

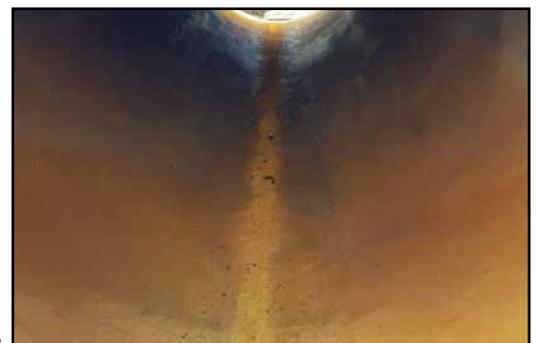
2.

Internal corrosion to the internals of a heat exchanger
