BELZONA PROTECTS CRUDE OIL HEX

Tubesheet, Channel end cover and Channel Shell of Crude Oil Heat Exchanger for an Oil & Gas Industry

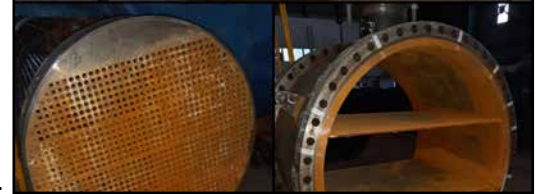
The Crude oil heat exchangers operate at up to 110°C and are prone to rapid corrosion. The separator channels and tube face can all suffer extreme corrosion decreasing the life of the equipment.

1. Equipment before application
2. Surface preparation done
3. Application with Belzona 1593 finished
