## BELZONA SEAL A TANK APPLICATION ON CRUDE STORAGE TANK AT A REFINERY

Refinery, Mumbai, India

Application was carried out on crude tank no 104. Diameter of tank is 54 meter. Tank is placed on a concrete foundation.

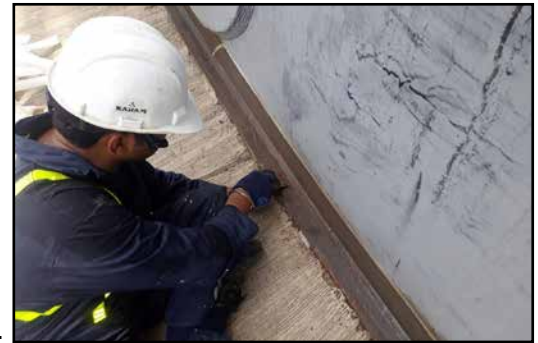
1. Surface preparation done on the shell and concrete base of the tank
2. Conditioner applied on the concrete base and the shell of the tank
3. Belzona 3111 along with Belzona 9311 was applied on the prepared surface of the tank
4. Final layer of Belzona 3111 has been applied and tape is ready for removal

Painting was removed from the shell upto a height of 0.2 meter from the base. The concrete was also cleaned and the surface was made clean dry and rough. Belzona 3911 (PSC) was applied on the concrete surface, Belzona 3921 ( GSC) was applied on the cleaned metallic surface of the tank. Belzona 3111 was applied on the prepared surface. Belzona 9611 along with Belzona 3111 was applied. After the application gets cured, a final layer of Belzona 3111 was applied.
