## BELZONA PROTECTS PHARMACEUTICAL PLANT FLOOR

Installation of a new positive grip flooring system on an outdoor concrete floor.

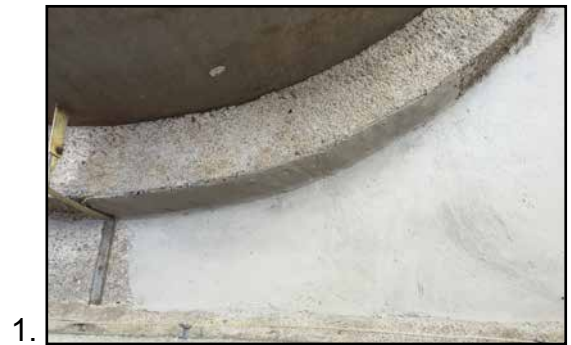
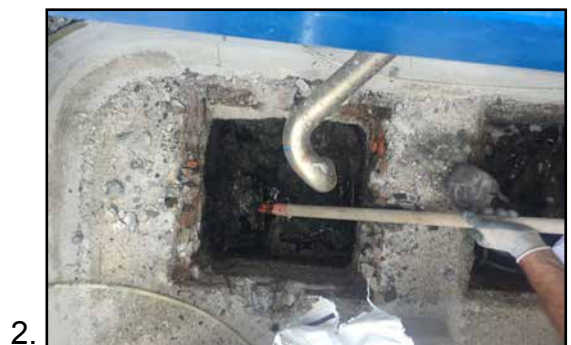
1. Before application
2. Before application
3. Final application
4. Final application

This plant floor and sump area were located outside and the outdoor roof didn't cover the full area, this was causing the concrete to degrade over time. Also, due to process there was occasional chemical spillages onto the concrete and therefore the client wanted the concrete sealing.

This application was carried out in accordance with system leaflet FPA-03. The concrete floor was prepared through grinding and cleaned before applying the Belzona 5231 with rollers.
