## BELZONA TECHNOSOL PROTECTS NEW SEA WATER PUMPS

New pumps requiring internal protection prior to going into service

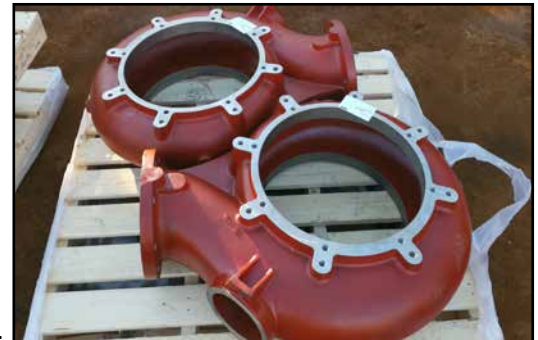
1. New pump components delivered for protection
2. Pieces grit blasted
3. Completed application of one of the pieces
4. Completed application
