## BELZONA REPAIRS LIGHT GAUGE CONVEYOR BELT

Large parcel distribution depot - Hinckley

March 2019

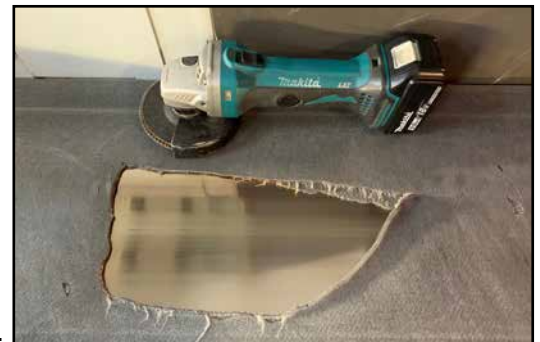
The large distribution center operate around 300 belts for conveying stock, mainly in plastic tote boxes. The boxes can approach 200Kg and fall through chutes hitting the moving belts. The belts are suffering damage and, at present, the client have no way of repairing the belts, forcing exchange at a cost of around £3,000 per belt.

1. Repair scenario (Power tool shown for scale)
2. Patch cut from spare belt
3. Masked area and repair being completed using 2311
4. Full repair completed. Repair time around 40 minutes

Application was carried out in accordance with a modified version of Belzona System Leaflet SHM-1. Following successful trial applications, the Belzona solution that was selected involved the cutting out of the damaged area. A patch was then created using a spare piece of conveyor belt. The new piece of belt was then bonded in place using Belzona 2311 (SR Elastomer).
