BELZONA HIGH TEMPERATURE LINING FOR NEW AUTOCLAVE

Vessel Fabricator, Flums, Switzerland

October, 2014

New carbon steel autoclave required corrosion protection.

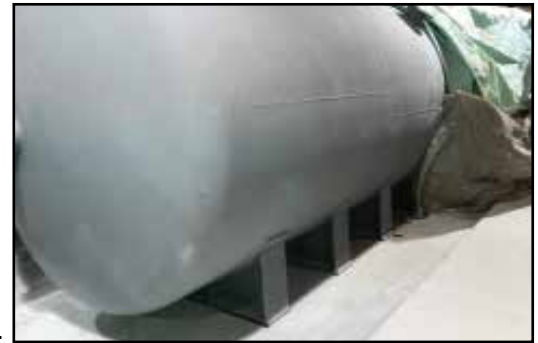
1. Outside view of autoclave
2. Autoclave ready for grit blasting
3. Lining application in action

The application was carried out in accordance with Belzona Know-How System Leaflet TCC-5. After grit blasting to SA 2.5 a two-coat system of Belzona 1593 was hand applied to an area of 45m² (484 ft²).
