## BELZONA 5721 - LEADING EDGE PROTECTION FOR COLD WEATHER BLADES

Wind Farm, Norway

2020

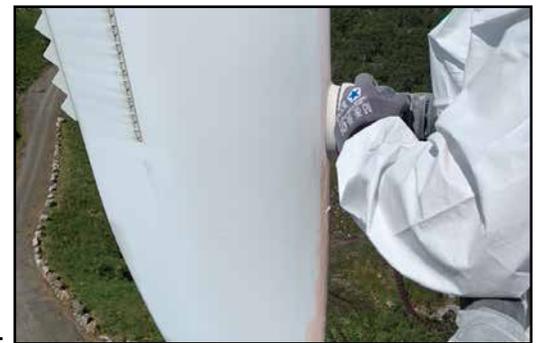
1. Product Training - Kit
2. Surface Preparation
3. Application in Progress
4. Norwegian Wind farm

The application was carried out in accordance with a modified version of Belzona Know-How System Leaflet FBC-1. The blades were coated on the turbine at the operation site. The pitting and loss of surface on the leading edge was resurfaced with a filler product and rebuilt to dimensions. The surface area was sanded down with a mechanical sander and cleaned with a rag and non-residual solvent cleaner. One coat of Belzona 5721 at 20 mils (508µm) was applied.
