BELZONA TECHNOSOL RESTORES CONCRETE SETTLEMENT TANK WALLS

Lancashire, UK

October 2020

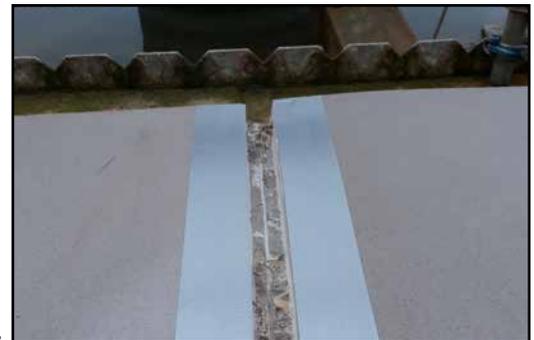
The top of the concrete walls of multiple FST's had suffered from abrasive wear due to the action of the wheels that drive the rotating separator arms. This has been further aggravated by freeze-thaw cycles on the damaged and damp concrete substrate. There has also been damage to expansion joints, which have been repaired previously, but began showing signs of failure.

1. Expansion joint before repair
2. Expansion joint after repair
3. Belzona 4131 during application
4. Repair completed

Belzona 4131 was applied to the top of the walls to create a hard, compression and abrasion resistant surface to provide long term protection and prolong its service life. The expansion joints were removed and replaced with Belzona 2211 to allow for the expansion/contraction of the concrete. The work was completed in accordance with Belzona System Leaflets TCC-09, TCC-11 & TCC-12.
