BELZONA DISTRIBUTOR'S OVEN HELPS QUICK RETURN TO SERVICE

Petrochemical

2020

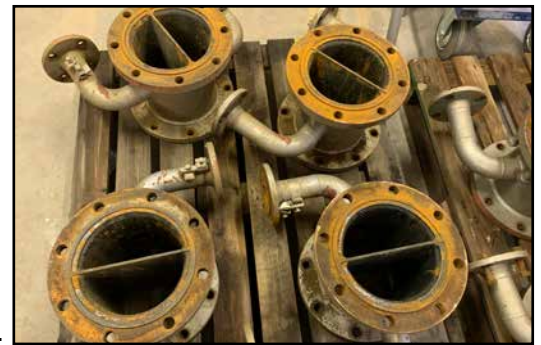
Customer needed to protect his parts of exchangers in cold temperature weather within 24 hours. Coating should be done with Belzona 5892.

1. Customer needed to protect his parts of exchangers
2. After blasting and cleaning
3. Parts of exchangers coated with Belzona 5892
4. Oven closing
