BELZONA COLD BONDING TECHNOLOGY PREVENTS PIPE VIBRATION

Petrochemical plant in Bohai, China

Petrochemical storage tank.

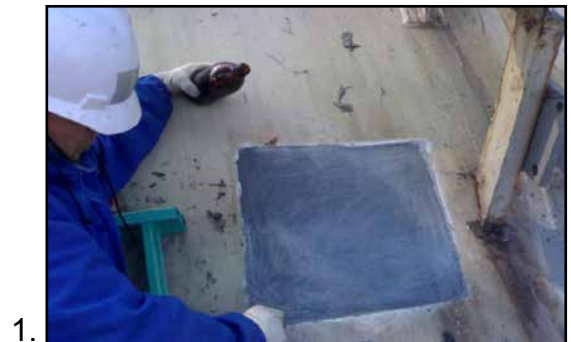
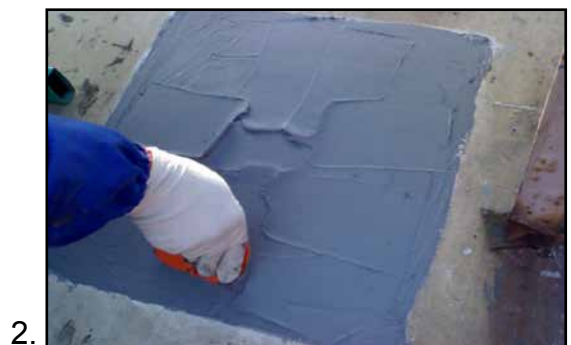
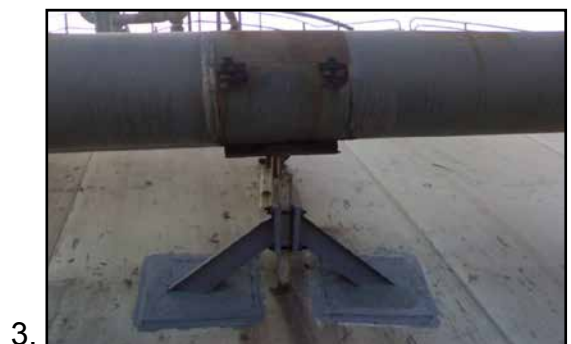
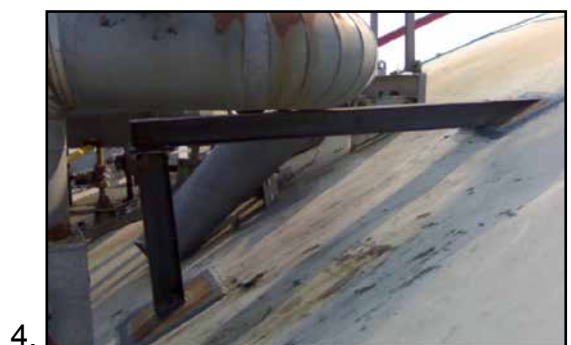
1. Surface preparation
2. Apply Belzona 1111
3. Application complete
4. Appearance of tank roof pipeline

By installing additional supports on the tank roof, Belzona provides customers with an effective solution eliminating vibration of pipelines. Cold bonding technology avoids hot work. This application was completed in only 4 hours.
