BELZONA CREATES ZONAL FLOOR MARKINGS

Glasgow, Scotland

February 2013

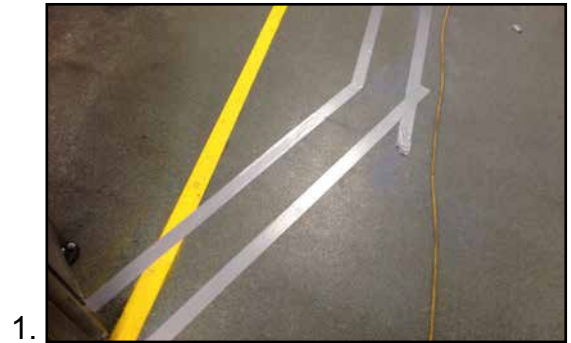
1. Taping out area
2. Zoned area
3. Completed application

The Application was carried out in accordance with Belzona System Leaflet FPA-08. The areas were roughed with floor grinders. The desired pattern was then taped out. Two coats of 5231 were then applied. A stencil was used to denote the 'zoned area' floor marking.
