BELZONA UPGRADES SAFETY GRIP SYSTEM AT UK COLLEGE FACILITY

A college facility in the UK contacted Belzona regarding the safety grip systems on various sets of steps on their site. The college was run via a charity supporting people with visual impairments and a variety of other disabilities.

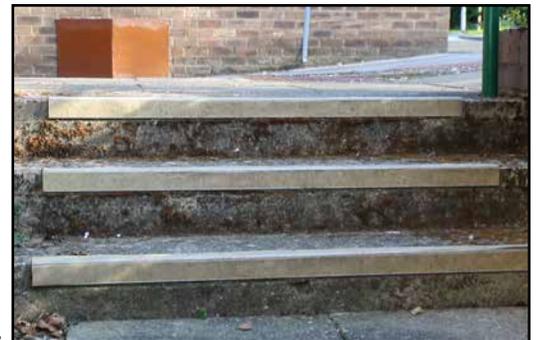
The safety grip systems in place on 3 separate sets of steps were ageing and no longer performing as intended. This was presenting a significant slip and trip hazard for the staff and students using the facility, warranting them to investigate a suitable replacement for the long term.

1. The old grip system had become redundant and was actually facilitating further damage to the concrete steps
2. Altogether, three sets of steps required a new grip system
3. Application of the Belzona grip system
4. Finished application

First, the existing grip system was removed from the concrete steps and preparation began to ensure a firm and clean substrate. Due to water ingress underneath the metal plates, there was some spalling concrete around the anchor points. Belzona 4141 was used to reform these areas and provide a neat edge on to which the new grip system could be applied. The Belzona 4411 and Belzona 9211 units were mixed then together and applied on to the concrete step nosings in strips.
