BELZONA PREVENTS SLIPS & TRIPS BY USING A POSITIVE GRIP COATING SYSTEM

Aluminium checker plate loading ramp.

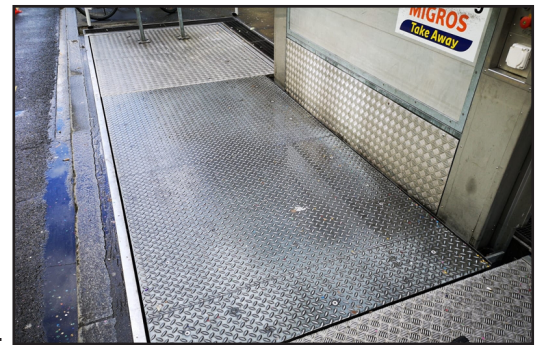
1. Original condition without Belzona
2. Security coating and marking area with Belzona 4411
