BELZONA PROTECTS NEW SEAWATER FILTERS FOR DESALINATION

CUSTOMER
Egypt

APPLICATION DATE
Oct-20

As part of the construction of a new Reverse Osmosis Desalination plant, 14 large media filters have been manufactured and are in need of internal protection.

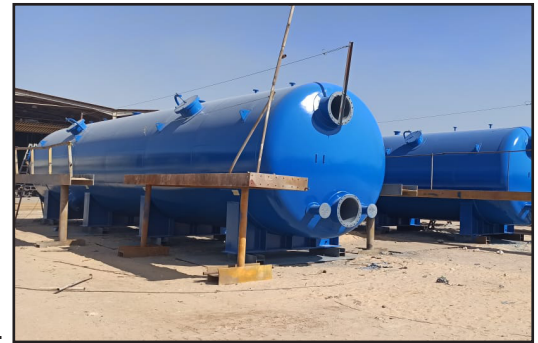
1. View of the filters from the outside
2. Internal surface after surface preparation
3. Internal surface after first coat
4. Completed application
