BELZONA STRENGTHENS NOZZLES OF TEG FLASH TANKS ON OFFSHORE PLATFORM

CUSTOMER
China

APPLICATION DATE
2017

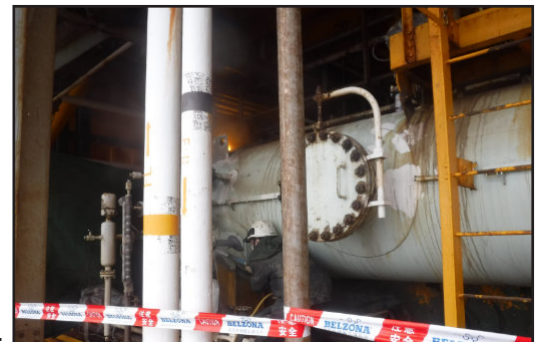
1. Surface preparation
2. Nozzles after blasting
3. Complete application of Belzona SuperWrap II
4. View of nozzles after 3 years

The repairs were designed in accordance with ISO24817 standard. The application was completed by Belzona trained and validated installers in accordance with Belzona Know-How System Leaflet VPF-11. Belzona supervisor and the on-site representative supervised the whole process. The whole application involved 8 two-inch nozzles.
