## BELZONA PROVIDES INNOVATIVE THERMAL INSULATION SOLUTION

A newly fabricated, aerial oil dispersant vessel to be used in cold environments, offshore.

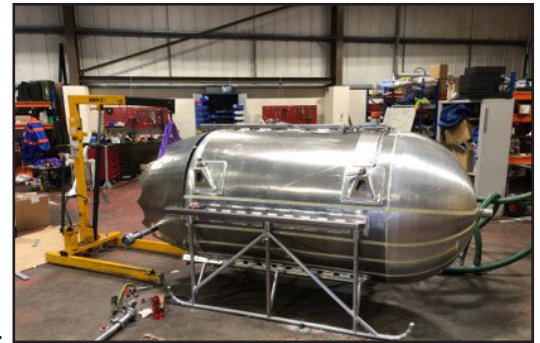
1. Fabricated aluminium vessel.
2. Blasted Vessel with trace heating positioned around vessel close-up of surface preparation.
3. Three coats of Belzona 5871 completed. Close up of trace heating panel to show the thickness of coating.
4. Vessel coating completed with a Belzona 3211 system applied. Ready to be transported to the client.
