BELZONA PROVIDES LEADING EDGE PROTECTION (LEP)

CUSTOMER
Doncaster

APPLICATION DATE
Sep-21

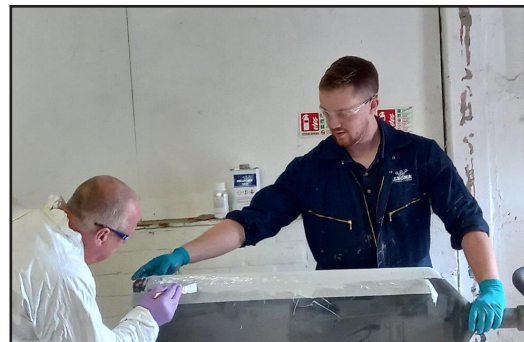
1. Training taking place
2. Blades awaiting preparation
3. Finished blades awaiting dispatch to site
4. Closer detail of finished LEP and full body protection coating

Training was given from the UK Sales Technical team to the contractors at their works. The blades were sanded to provide a key then 2 x coats of 5811 were applied to the total surfaces of the fan blades. After curing, the 5811 was again abraded along on the leading edge, approximately 80 mm either side of the blade's leading edge to the length of the blade. 2 coats of 5721 was then applied to complete the protective application
