# Steel Mill Office Floor Protected with Belzona 5231

ID: 10020

Industry: *Steel & Metal Processing*  
Application: *FPA-Floor Problem Areas*  
Substrate: *Concrete*  
Products: *Belzona 5231 (SG Laminate), Belzona 5233*

Customer Location: *Detroit, MI*  
Application Date: *December 2018*

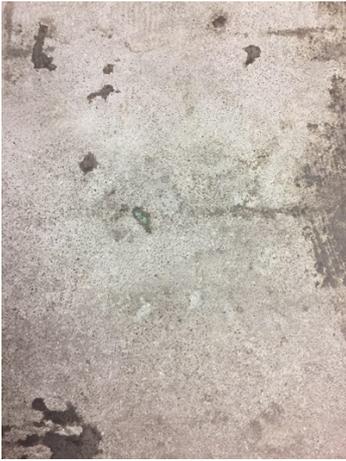
*The offices concrete floors were worn. The customer was looking for a non-slip epoxy coating that would provide years of service.*

The office floors were in this condition
