Acid Containment Drain Coating with Belzona 4311

ID: 10035

Application: FPA-Floor Problem Areas

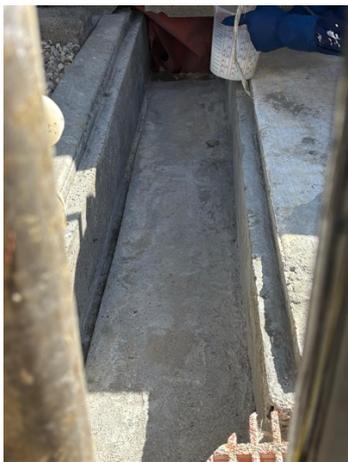
Image of the relatively new poured concrete drain area, before the coating work began

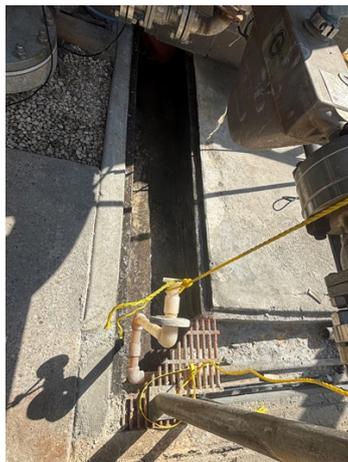
Belzona 4911 conditioner applied

We performed a moisture test with a protimeter to confirm moisture level was below 6%, on this relatively new poured concrete. We used handheld grinders with a turbocup diamond grinder attachment to prep the concrete. The grinder we used had a dust collection extraction shroud attachment on it to help collect dust. We applied Belzona products using stiff bristled nylon brushes, with bristles cut in half.

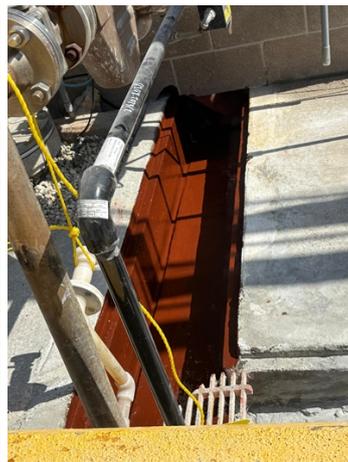
Belzona 4311 application complete
