Engineering plant roof benefits from the Belzona roof treatment

ID: 10041

Application: RPA-Roof Problem Areas

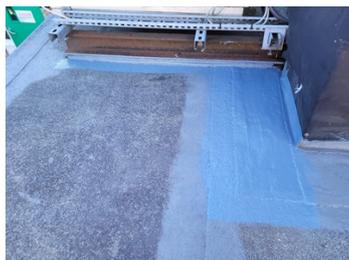
Numerous leaks were causing difficulties in a large engineering workshop. Equipment and stock were becoming compromised by continuous water ingress.

Close up of a typical example of the numerous failures found on the engineering workshop roof.

All the existing roof was cleaned and pressure washed.

2 coats of Belzona 3131 were finally applied to completely encapsulate the roof area.

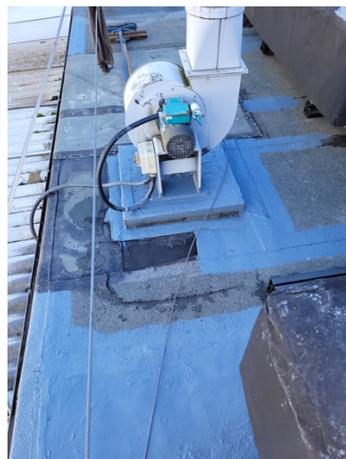
Completing detailed works around one of the many service assets which populated the roof.

Attention was given to all intricate areas and difficult interfaces.

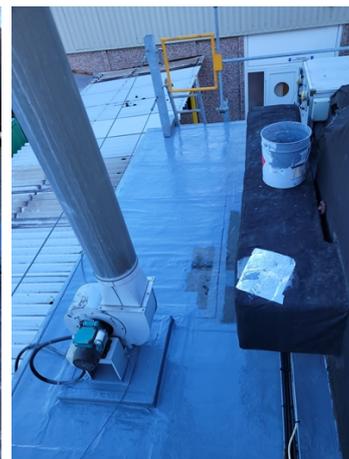
Further detailed preparatory works before final coats are applied.

Belzona 3921 was used to condition any non-porous substrates where the Belzona 3131 was to be applied.
