Louisiana Channel's the Belzona 5821

ID: 10044

Industry: Power
Application: HEX-Heat Exchangers
Substrate: Carbon steel
Products: Belzona 1121 (Super XL-Metal), Belzona 5821

Customer Location: Lena Louisiana
Application Date: October 2025

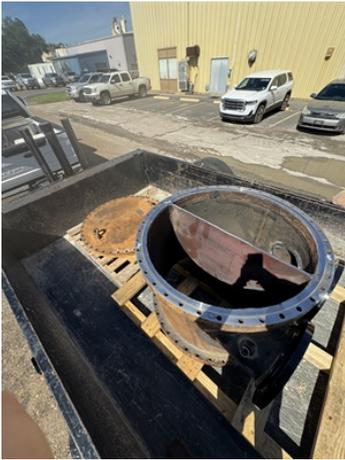
Corroded and pitted channel head, divider plate and end cover

When the channel head was delivered

We grit blasted to a 3 mil angular profile. Applied Belzona 1121 to smooth substrates and fill pitting. Brushed on two coats of Belzona 5821 for protection.

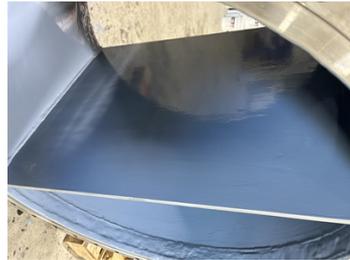
The channel and divider plate rebuilt with Belzona 1121 and protected with two coats of Belzona 5821

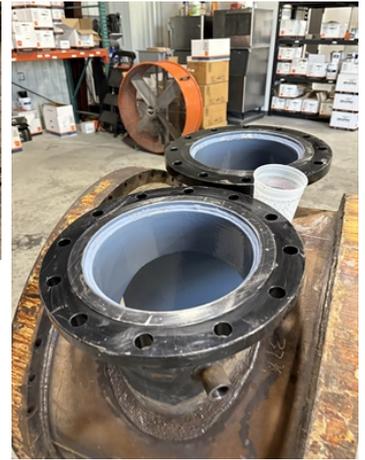
Top of Channel head
