Belzona SuperWrap II Applied on a 58" Flare Line at a Petrochemical Plant in Saudi Arabia

ID: 10072

Industry: Chemical & Petrochemical
Application: VPF-Valves, Pipes and Fittings

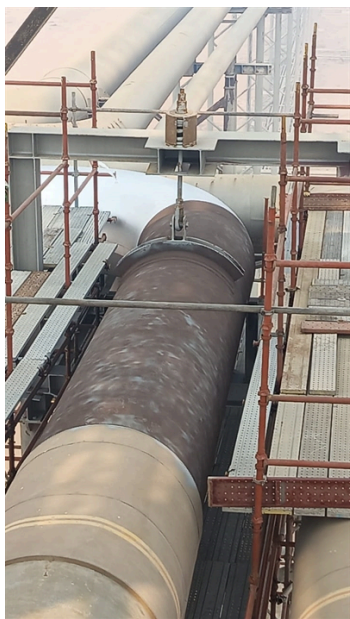
A 58" flare line in a petrochemical plant had suffered significant wall-thickness loss, compromising its structural integrity.

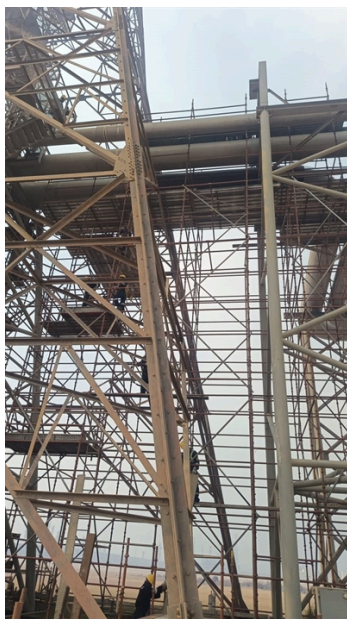
General overview of the flare line structure.

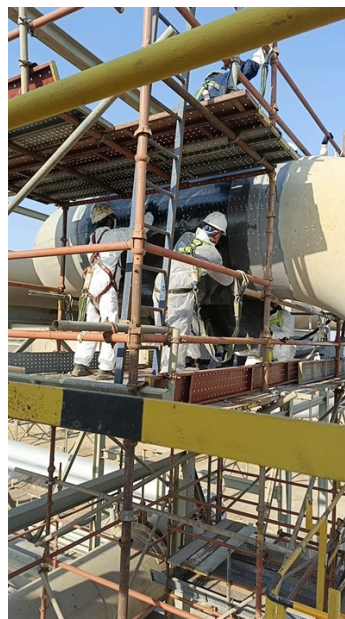
Application of the Belzona SuperWrap II system in progress.

Using Belzona 1983 (SuperWrap II) resin with Belzona 9381 carbon fiber reinforcement sheets, the repair restored the flare line's integrity and ensured a durable, long-term solution.

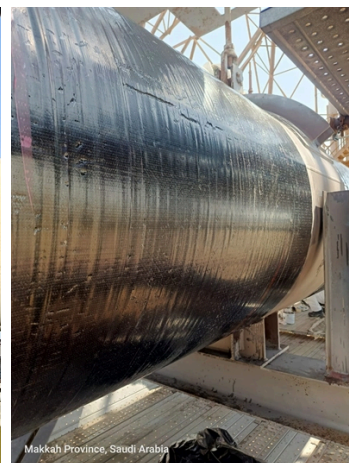
Completed application of Belzona SuperWrap II on the flare line.

Using Belzona 1983 (SuperWrap II) resin in combination with Belzona 9381 carbon fiber reinforcement sheets, the repair successfully restored the flare line’s integrity and provided a durable, long-term solution. This innovative application not only extended the service life of the flare line but also enabled the refinery to achieve significant cost savings and avoid an unplanned shutdown.
