Belzona SuperWrap II Applied on a 58" Flare Line at a Petrochemical Plant in Saudi Arabia

ID: 10072

Customer Location: Rabigh, Saudi Arabia

Application: VPF-Valves, Pipes and Fittings

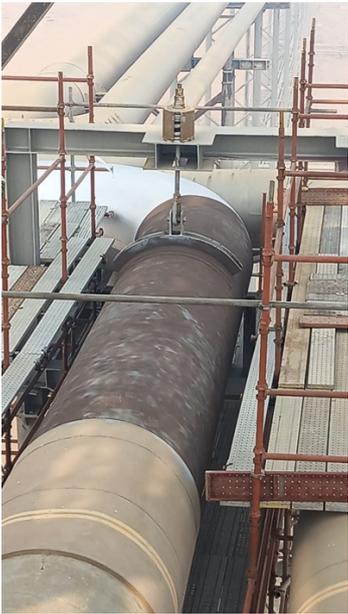
A 58" flare line in a petrochemical plant had suffered significant wall-thickness loss, compromising its structural integrity.

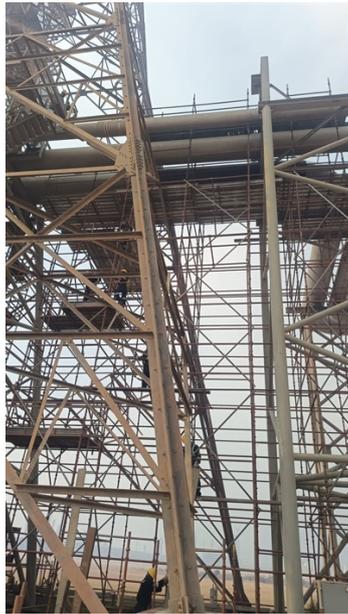
General overview of the flare line structure.
