# Damage from Trailer landing legs, repaired by Belzona

ID: 10073

Industry: Chemical & Petrochemical  
Application: FPA-Floor Problem Areas  
Substrate: Concrete  
Products: Belzona 4131 (Magma-Screed), Belzona 4911 (Magma TX Conditioner)

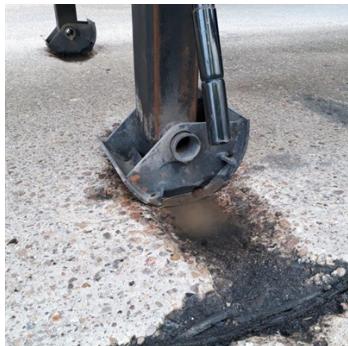
The Landing legs on the 40' trailers had worn depressions into the concrete floors. These were causing problems with fork lift traffic and other vehicles as some of the depressions were over 40mm deep

Showing landing legs causing wear to concrete parking area near loading doors

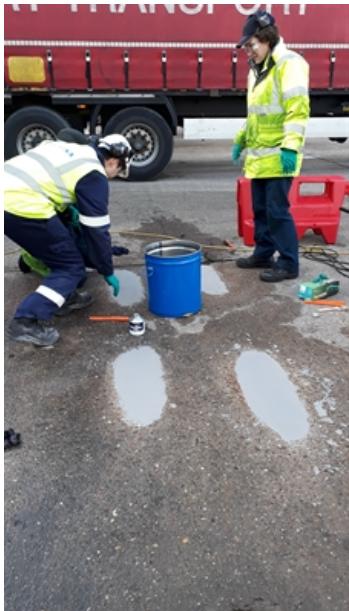
Areas cleaned and dried, the conditioned with Belzona 4911

Completed with Belzona 4131 and feather edged
