Belzona Slopes Catalyst

ID: 10089

Industry: Chemical & Petrochemical
Application: TCC-Tanks and Chemical Containment Areas

Customer Location: Lafayette LA
Application Date: November 2025

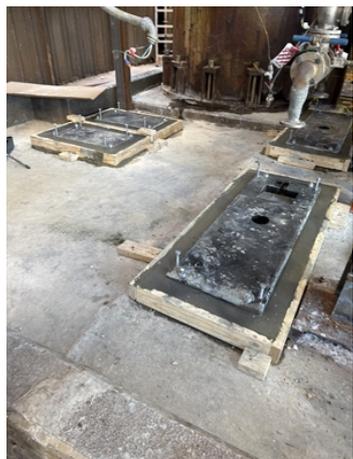
Contractors setting up the pump bases.

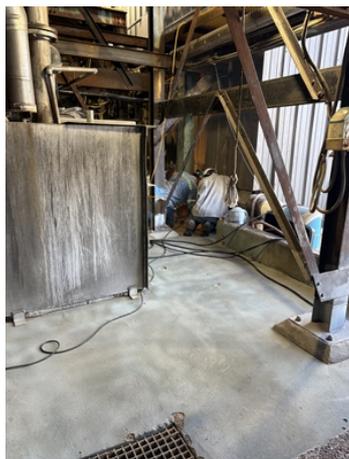
Containment after being cleaned and grit blasted.

Grit blasted area with aluminum oxide, troweled on Belzona 4124 to make floor to wall transitions. Applied two coats of Belzona 5811 using brushes.

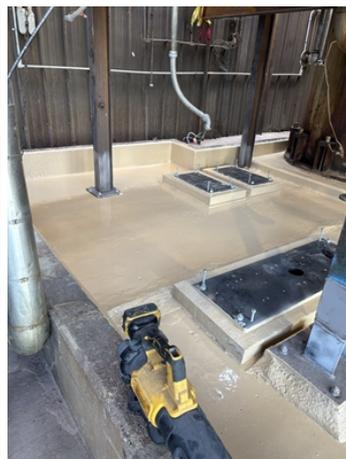
Containment during first coat of Belzona 5811.

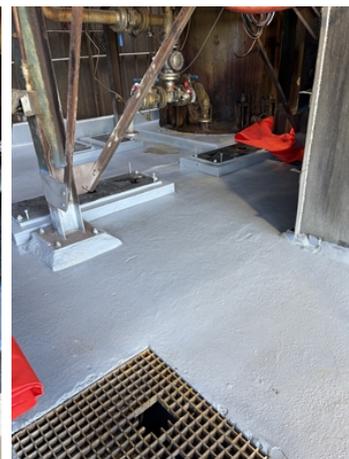
Containment after top coat of Belzona 5811.
