Protective Internal Coating for Newly Fabricated Sour Gas Scrubber Trap

ID: 10096

Industry: *Oil & Gas*
Application: *VPF-Valves, Pipes and Fittings*
Substrate: *Carbon steel*
Products: *Belzona 1391S*

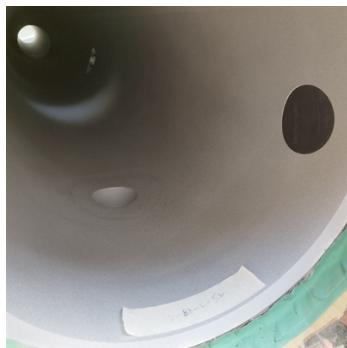
Condition of the substrate after grit blasting and before internal coating application.

1. The surface was grit blasted to achieve the required level of cleanliness.
2. The first internal coat of Belzona 1391S (grey) was applied using spin spray technology.
3. As Belzona 1391S is a two-coat system, once the first coat was sufficiently firm, the second coat of Belzona 1391S (blue) was applied to protect the scraper trap substrate against corrosion and erosion.
