BELZONA RESURFACES LAB TABLES

ID: 1010

Industry: *Buildings & Structures*
Application: *FPA-Floor Problem Areas*
Substrate: *Soapstone*
Products: ** Belzona 5811 (Immersion Grade) ,*

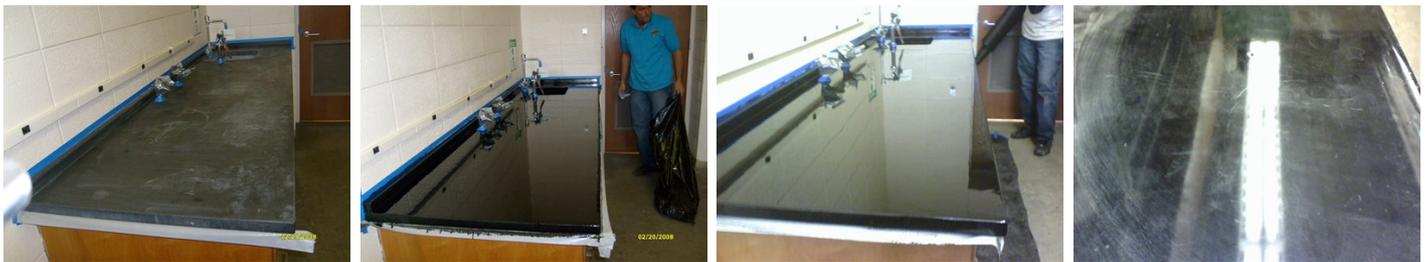
Photograph Descriptions

At Georgia Tech, customer wanted to provide a durable surface without having to replace soapstone tables of 40 years of wear and tear have degraded tables.

- * 1. View of original table ,
- * 2. Application of first coat ,
- * 3. Completed application ,
- * 4. After 5 years, another lab top table was being repaired. Lab was being rebuilt, but the tops were remained. ,

Sanding tables to provide a good profile. Then applied two coats of Belzona 5811.
