# BELZONA RESURFACES LAB TABLES

ID: 1010

Industry: *Buildings & Structures*  
Application: *FPA-Floor Problem Areas*  
Substrate: *Soapstone*  
Products: *\* Belzona 5811 (Immersion Grade) ,*

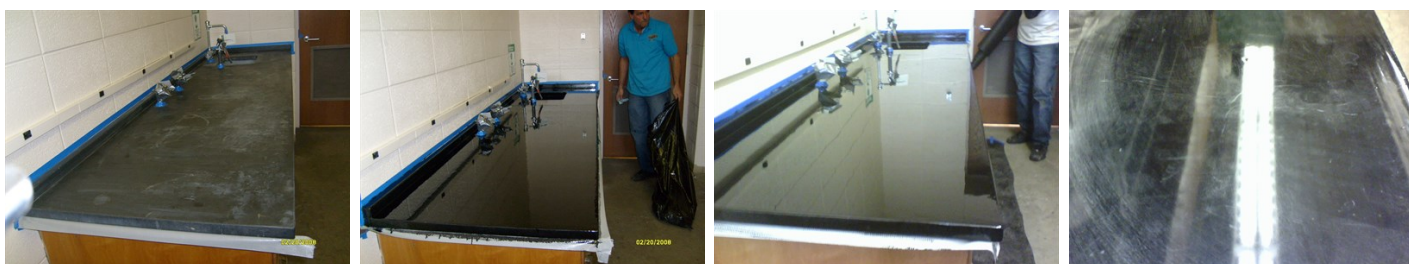
*At Georgia Tech, customer wanted to provide a durable surface without having to replace soapstone tables of 40 years of wear and tear have degraded tables.*

- \* 1. View of original table ,
- \* 2. Application of first coat ,
- \* 3. Completed application ,
- \* 4. After 5 years, another lab top table was being repaired. Lab was being rebuilt, but the tops were remained. ,

Sanding tables to provide a good profile. Then applied two coats of Belzona 5811.
