# Chiller Internal Rebuild and Protection with Belzona 1121 & 1321

ID: 10117

**Industry:** Heating, Ventilation & Air Conditioning  
**Application:** HEX-Heat Exchangers  
**Substrate:** Carbon steel  
**Products:** Belzona 1121 (Super XL-Metal), Belzona 1321 (Ceramic S-Metal)

**Customer Location:** Orlando, Florida – Universal Studios  
**Application Date:** December 2025

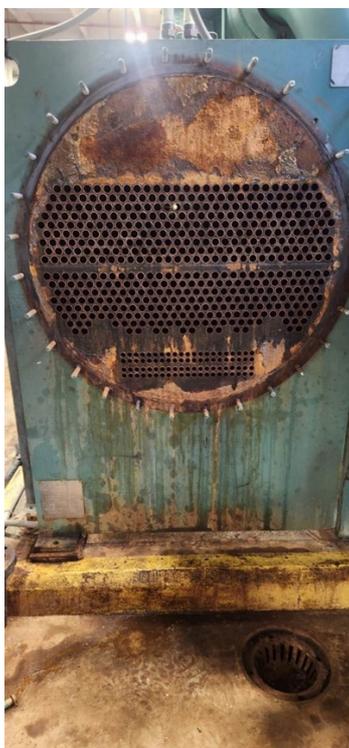
Severe corrosion present on the tube sheet of the YORK MaxE chiller, showing metal loss, scaling, and deterioration around the tube openings prior to surface preparation.

The surfaces were prepared by abrasive blasting to SSPC-SP10 (Near White Metal), achieving a clean profile suitable for Belzona adhesion. Dust and contaminants were removed using clean, dry air.

Belzona 1121 was then applied by hand using applicators and spatulas to rebuild areas of metal loss on the tube sheet and end cover. The material was worked into the substrate to ensure full wet-out and restored geometry.

Once curing allowed, Belzona 1321 was applied in two coats using brushes and smoothers to create a uniform, corrosion-resistant lining on the diffuser, water box, and rebuilt areas. Wet film thickness checks were performed throughout the process to ensure correct coverage.

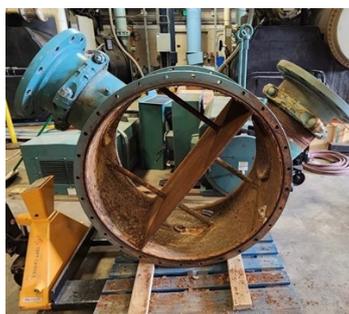
Internal corrosion inside the diffuser and water box area of the YORK MaxE chiller, showing severe rusting, pitting, and metal degradation before blasting and rebuilding.

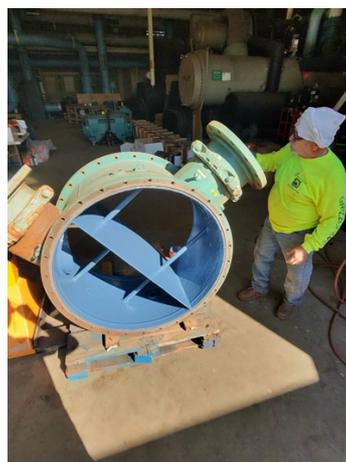
Diffuser section after surface preparation, rebuilding, and full application of Belzona 1321, providing a smooth, durable erosion- and corrosion-resistant lining.

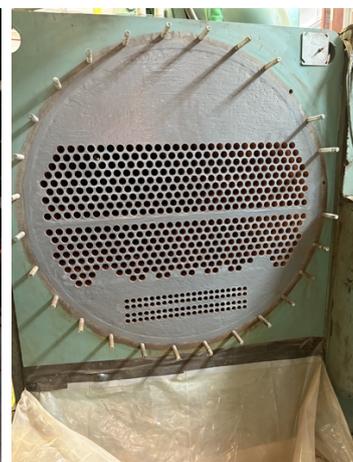
Tube sheet restored with Belzona 1121 for rebuilding and fully coated with Belzona 1321 to provide long-term protection against corrosion and erosion. Surface restored to a smooth, uniform finish ready for reassembly.
