Massive Seawater Evaporator Protected with Belzona 5892 at a Power Plant in Saudi Arabia

ID: 10118

Industry: Power
Application: TCC-Tanks and Chemical Containment Areas
Substrate: Carbon steel
Products: Belzona 1511 (Super HT-Metal), Belzona 5892

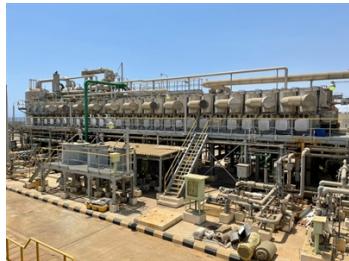
General overview of the seawater evaporator

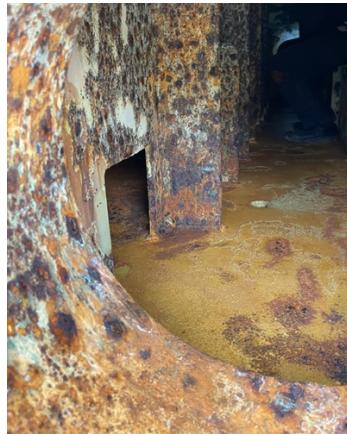
A seawater evaporator at a power plant in Saudi Arabia was facing a severe internal corrosion issue.

Condition before Belzona 5892 application

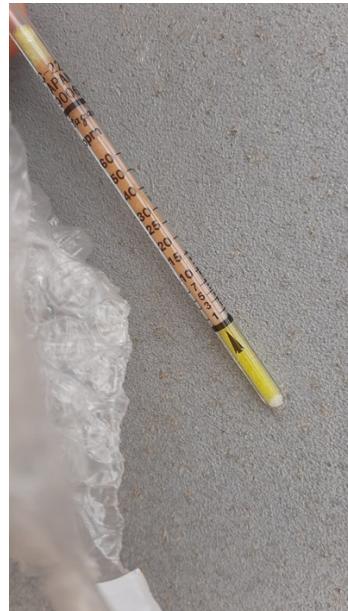
After grit blasting surface preparation and salt testing

The Belzona 5892 system was applied on the seawater evaporator following a strict procedure: the surface was first prepared by abrasive blasting to achieve Sa 2½ cleanliness and a 75 micron profile using a grit blasting system. After thorough cleaning and inspection, deep pitting was rebuilt with Belzona 1511 (Super HT-Metal) and then Belzona 5892 was applied in two coats to meet the specified thickness. Wet film gauges were used during application, and curing was monitored as per the data sheet, followed by final checks using a holiday detector and dry film thickness gauge.

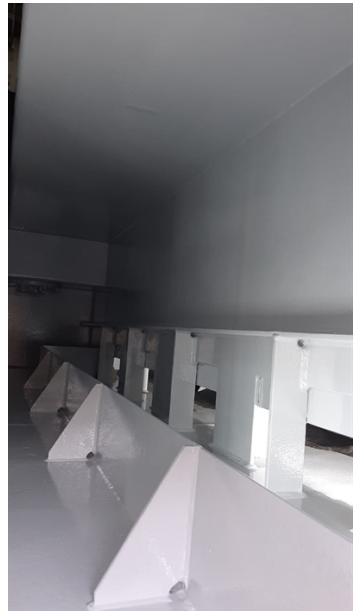
Completed application of Belzona 5892 system
