# Belzona 1984 Surface Tolerant Super Wrap II

ID: 10144

**Application:** VPF-Valves, Pipes and Fittings

**Substrate:** Carbon steel

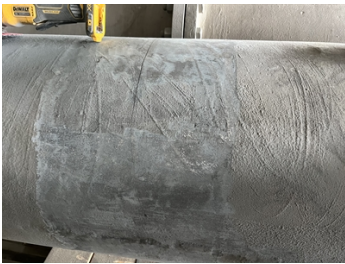
This picture allows you to see how we prepped the surface with a MBX bristle blaster.

For this application we used an MBX Bristle Blaster and a grinder to prepare the surface. Followed by cleaning with 100% non-recycled MEK. Once the pipe was prepped and cleaned we the pre-fit the Belzona Super Wrap II then cut three wraps. Then we pre-fit the consolidation tape. Followed by mixing Belzona 1984 to Belzona specs. Next we mixed the 1984 into the Super Wrap II and applied to the surface area followed by applying the Super Wrap II to the pipe with three separate wraps to ensure proper thickness. Finally completing the wrap system by applying the red consolidation tape. We used a temperature reader along with surface temperature and humidity readings to ensure proper working environment. This application required a six month inspection by the client. It was recently inspected in October 2025 and was passed by client and contractor.

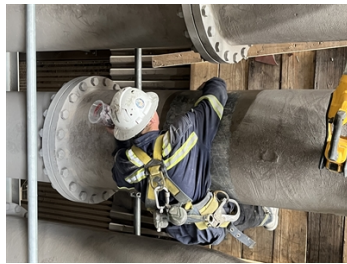
The photo show you how large this pipe was compared to one of our applicators.

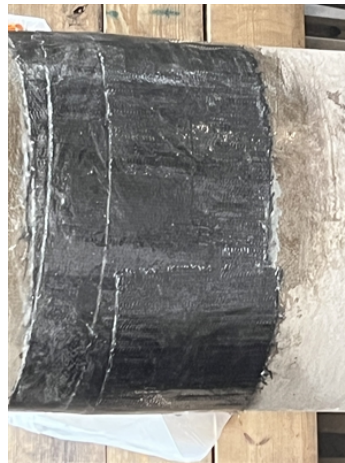
Here you can see we wrapped the pipe with three Belzona Carbon-Glass Fiber Super Wraps.

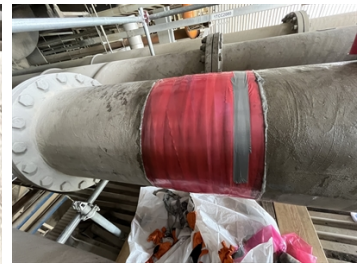
Completed photo of Belzona 1984 Carbon-Glass Fiber Super Wrap II
