# Belzona 1984 Surface Tolerant Super Wrap II

ID: 10144

**Application:** VPF-Valves, Pipes and Fittings

The client was dealing with a serious issue of thin walled piping.

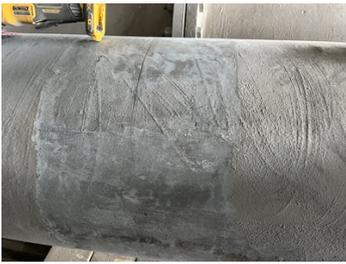
This picture allows you to see how we prepped the surface with a MBX bristle blaster.

For this application we used an MBX Bristle Blaster and a grinder to prepare the surface. Followed by cleaning with 100% non-recycled MEK. Once the pipe was prepped and cleaned we the pre-fit the Belzona Super Wrap II then cut three wraps. Then we pre-fit the consolidation tape. Followed by mixing Belzona 1984 to Belzona specs. Next we mixed the 1984 into the Super Wrap II and applied to the surface area followed by applying the Super Wrap II to the pipe with three separate wraps to ensure proper thickness. Finally completing the wrap system by applying the red consolidation tape. We used a temperature reader along with surface temperature and humidity readings to ensure proper working environment. This application required a six month inspection by the client. It was recently inspected in October 2025 and was passed by client and contractor.

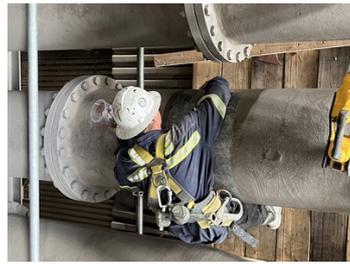
The photo show you how large this pipe was compared to one of our applicators.

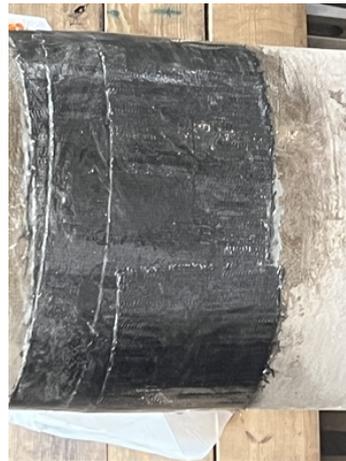
Here you can see we wrapped the pipe with three Belzona Carbon-Glass Fiber Super Wraps.

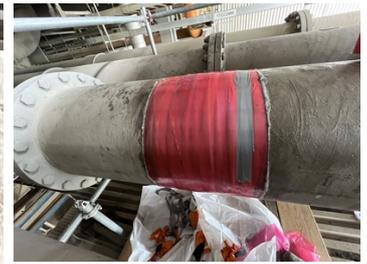
Completed photo of Belzona 1984 Carbon-Glass Fiber Super Wrap II
