Belzona 1984 Super Wrap II

ID: 10147

Application: *VPF-Valves, Pipes and Fittings*

Products: *Belzona 1984, Belzona SuperWrap II, Monti® MBX® Bristle Blaster®*

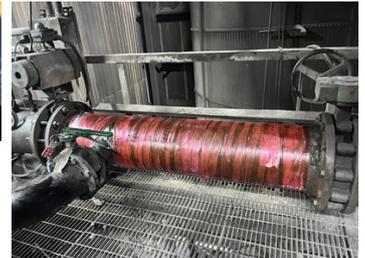
Up close of applying Belzona 1984 and Super Wrap II

Using handheld grinders and a MBX Bristle Blaster we prepared the surface by removing years of buildup and rust. Followed by cleaning the surface using 100% MEK. Next, we pre-fit and cut the Carbon Fiber Super Wrap II three times for a 3-wrap system followed by pre-fit and cut of the consolidation tape. To complete the application, we applied Belzona 1984 to the pipes surface then to the Carbon-Glass Fiber Super Wrap II. Applying each wrap one at a time followed by the consolidation tape.
