# Belzona 4181 trench and containment protection

ID: 10184

Industry: *Chemical & Petrochemical* Customer Location: *Pasadena, TX*  
 Application: *TCC-Tanks and Chemical Containment Areas* Application Date: *March 2022*  
 Substrate: *Concrete*  
 Products: *Belzona 4181 (AHR Magma-Quartz), Belzona 4981 (Magma HT Conditioner)*

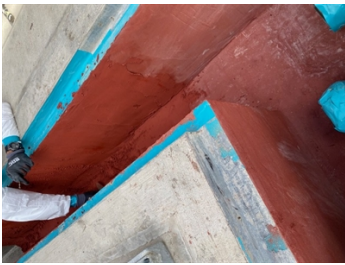
Belzona 4181 AHR Magma Quartz being applied to new build 2022.

Concrete areas were allowed to cure for over 28 days. Surface was blasted and power washed. Application of Belzona 4181 was carried out by hand trowel.

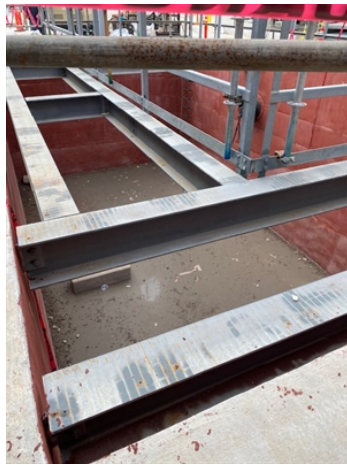
Dump pit halfway completed with Belzona 4181 AHR Magma Quartz.

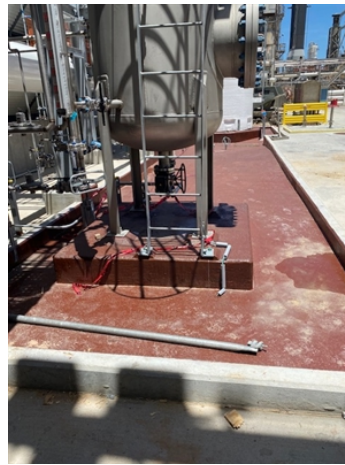
Completed secondary containment area.

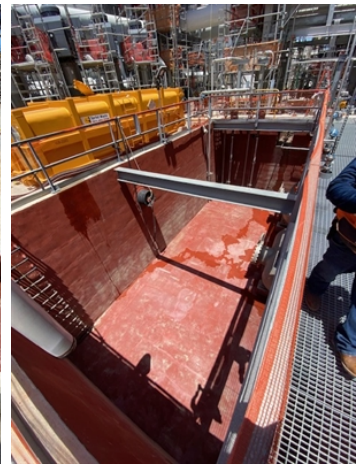
After four years of service, all areas are still in excellent shape when viewed in 2026 during routine cleaning and inspection.
