Belzona 4181 trench and containment protection

ID: 10184

Application: TCC-Tanks and Chemical Containment Areas

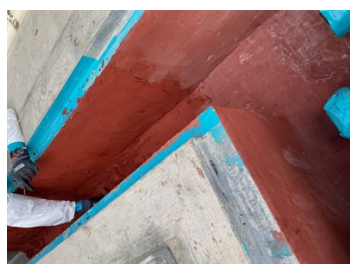
Belzona 4181 AHR Magma Quartz being applied to new build 2022.

Concrete areas were allowed to cure for over 28 days. Surface was blasted and power washed. Application of Belzona 4181 was carried out by hand trowel.

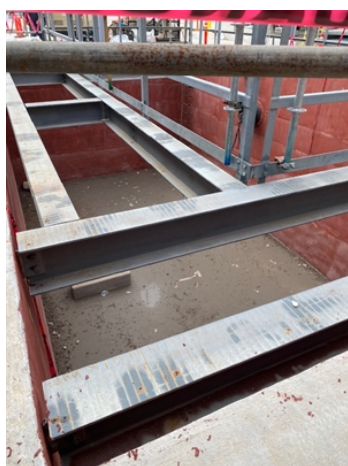
Dump pit halfway completed with Belzona 4181 AHR Magma Quartz.

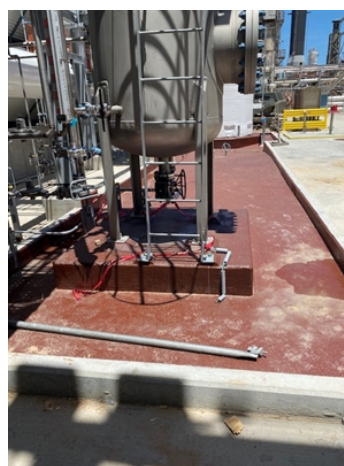
Completed secondary containment area.

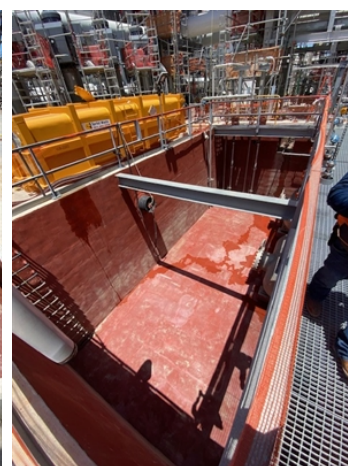
After four years of service, all areas are still in excellent shape when viewed in 2026 during routine cleaning and inspection.
