Attaching Steel Platform to Concrete Roof Using Belzona 4111/4911

ID: 10241

Application: FPA-Floor Problem Areas

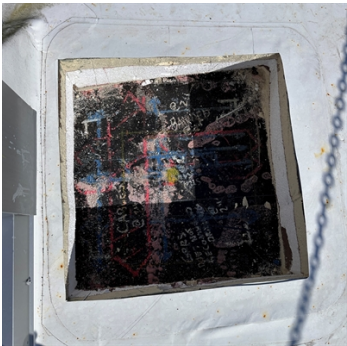
Roof surface showing interference inside roof slab

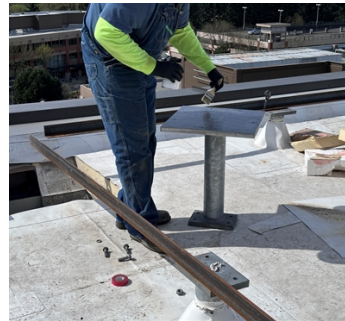
Applying Belzona 4911 Surface Conditioner

concrete and the prepared steel as a bonding primer to penetrate the substrates and maximize adhesion of the paste grade material. Belzona 4111 (Magma-Quartz) was mixed and trowel applied to form the structural bond line between each leg plate and the roof slab, with the plates bedded and aligned into the wet paste to achieve full contact. All work was performed in accordance with Belzona's Instructions for Use (IFU's). Total hands-on application time for all five leg plates was approximately four hours, and the assembly was left undisturbed for a two-day cure before the steel platform was loaded.

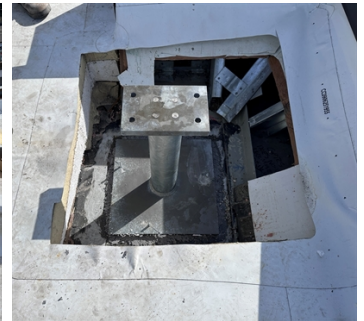
Final Application with 1/4" of Belzona 4111
