Belzona Bracket Bonding on a Warship

ID: 10246

Industry: *Military*
Application: *SOS-Ships and Offshore Structures*

Customer Location: *Devonport, New Zealand*
Application Date: *April 2026*

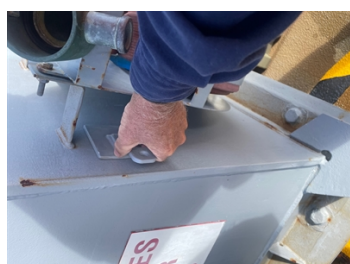
Client demonstrated the optimum location for the installation

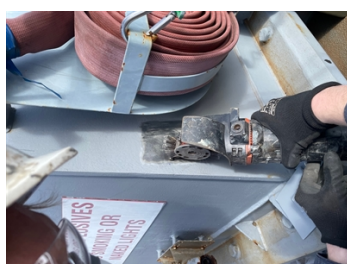
an MBX was used to remove existing paintwork and profile the area outlined for installation

No specialist tools were required for this application; Surface preparation was completed using a battery grinder and an MBX to ensure it complied with the SSPC-SP11 specification. Belzona 1161 (Super UW-Metal) was mixed in small quantities and applied using a short, bristled brush to both the bracket and the bulkhead. The 1161 (Super UW-Metal) on the bracket was peaked in the centre with an applicator to ensure good squeeze out upon contact, this extruded product was then removed with a clean spatula.

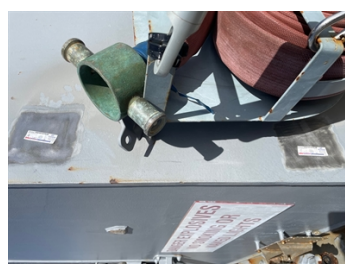
Surface profile was measured to an acceptable 55-65 microns in the installation areas

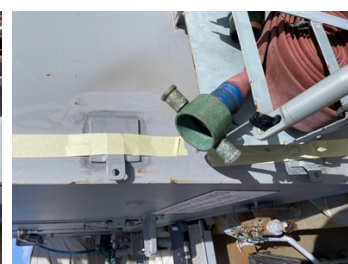
Belzona 1161 (Super UW-Metal) was chosen due to unpredictable weather conditions, once the brackets had been applied, tape was used to secure the bracket into position whilst curing
