# SUPER FERRY PROTECTED WITH BELZONA

Industry: *Marine*  
Application: *SOS-Ships and Offshore Structures*

Customer Location: *Shipyards, Mobile, Alabama*  
Application Date: *November 2007*

Substrate: *Aluminum*  
Products: *Belzona® 1321 (Ceramic S Metal)*

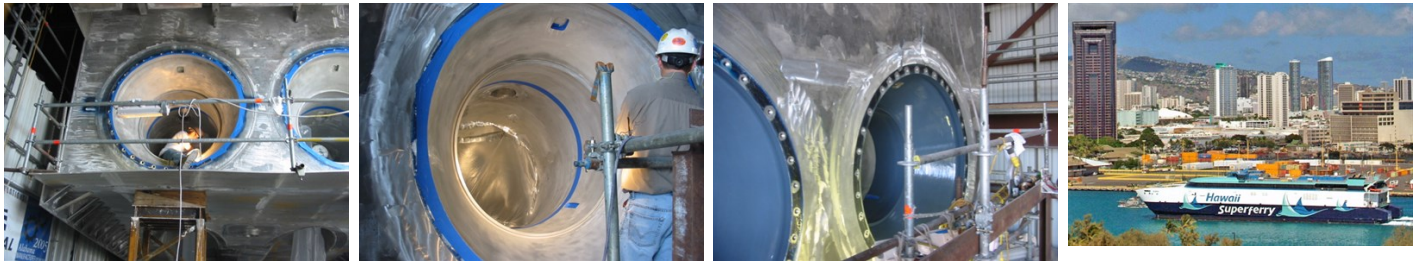
*With the stainless components of the propulsion system being in close proximity to the aluminum housing, the effects of electrolysis would deteriorate the housing.*

\* View of the jet drive housing , \* Close up of the housing prior to coating , \* View of the housings being protected with Belzona® 1321 , \* Arrival of the new ferry ,

Jet drive housings on new construction of a high speed ferry.

The application was carried out in accordance with the Belzona Know-How System Leaflet SOS-2.
