SUPER FERRY PROTECTED WITH BELZONA

Industry: Marine
Application: SOS-Ships and Offshore Structures

Substrate: Aluminum
Products: Belzona® 1321 (Ceramic S Metal)

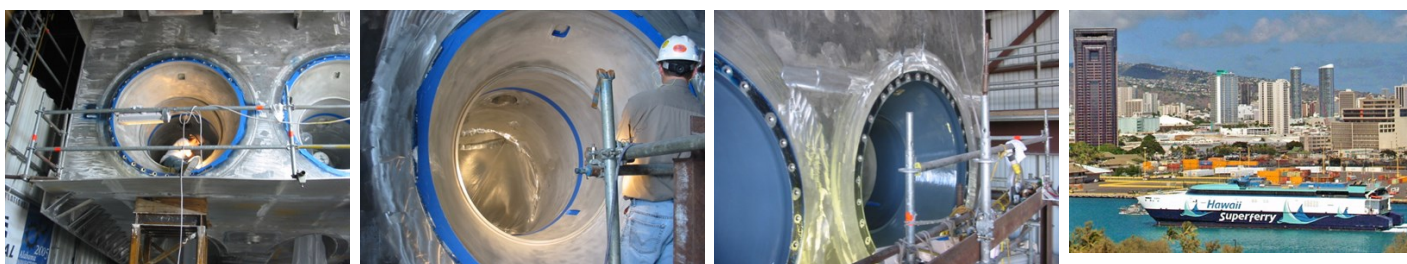
Photograph Descriptions

With the stainless components of the propulsion system being in close proximity to the aluminum housing, the effects of electrolysis would deteriorate the housing.

* View of the jet drive housing , * Close up of the housing prior to coating , * View of the housings being protected with Belzona® 1321 , * Arrival of the new ferry ,

Jet drive housings on new construction of a high speed ferry.

The application was carried out in accordance with the Belzona Know-How System Leaflet SOS-2.
